**SAS Superstructure**

Daily Diary Report by Bid Item

Contract No.: 04-0120F4

Diary #: 104 Const Calendar Day: 323 Date: 28-Jul-2010 Wednesday

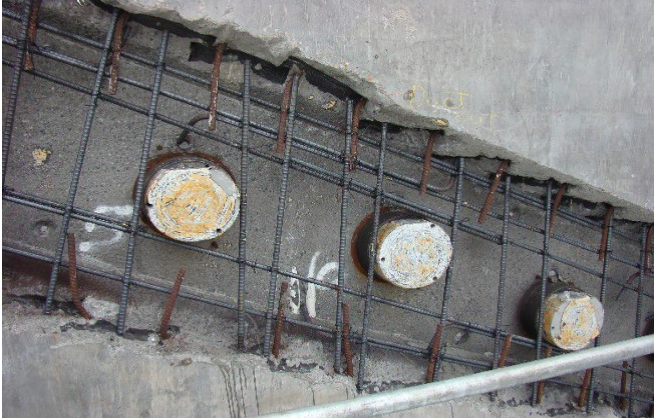
Residual foam from the #16 dowels is still on the concrete of the E and W blockouts in addition to grease on the grout caps that needs to be cleaned.

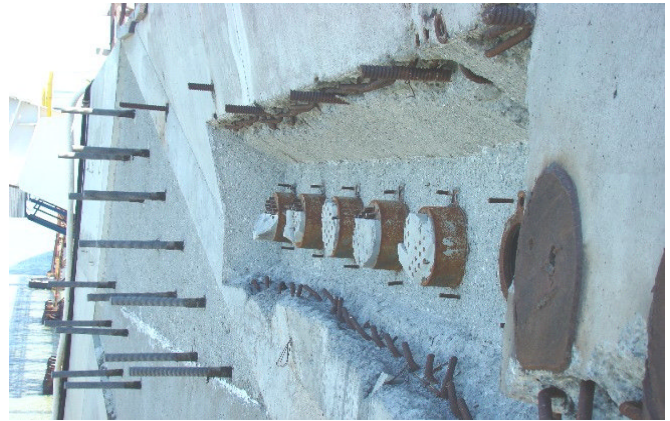
Rust accumulating on the CBT-11 to 15 anchorheads, wedges, and strands.
